**Phase I Environmental  
Site Assessment Report**

**Office Building  
3440 Sojourn Drive  
Carrollton, TX 75006**

Job Number: 2006-1  
01/13/2006

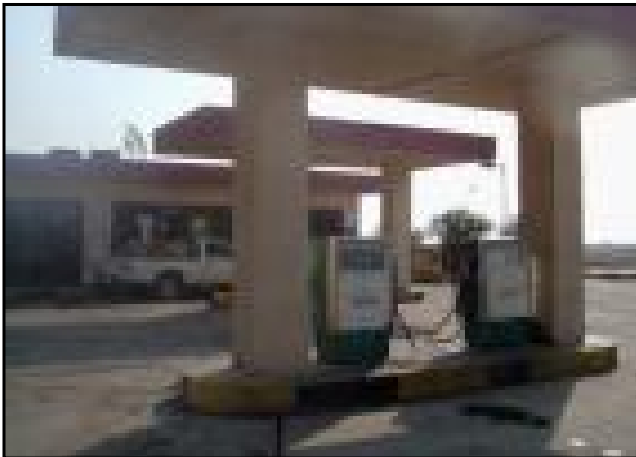
<i>Use Status</i>	<i>Year Installed</i>	<i>Capacity (gals.)</i>	<i>Contents</i>	<i>Construction Materials</i>	<i>Comments</i>
No longer utilized	1960	5000	Gasoline	Steel	Tank is scheduled to be removed

View of dispensers and island.

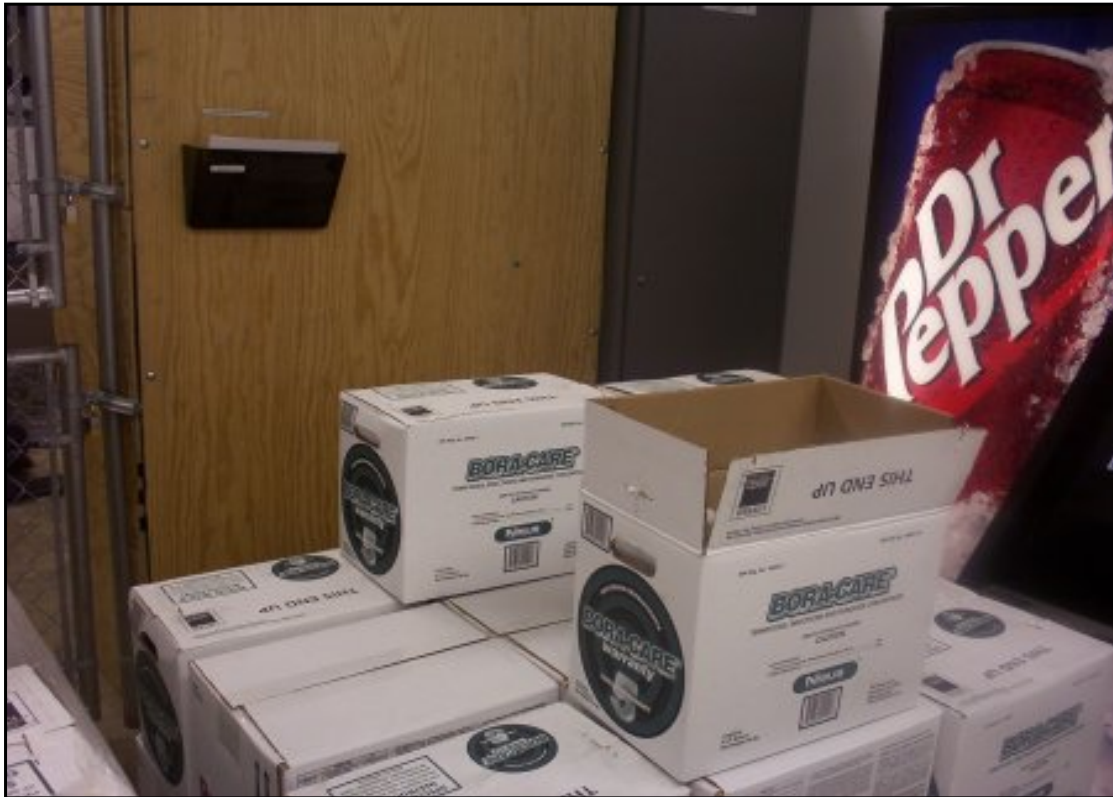
Stored Termite Chemicals 2

Team – Pest Defense which is the tenant in Suite # 150 of Building One treats buildings for termites. They store chemicals for this purpose in a storage room of their suite. The storage room is locked and the chemicals are stored in one-gallon plastic containers which are stored in cardboard boxes. Home Team has a locked gate in the storage room and keeps some pesticides in that area and other pesticides in the storage room but not behind the locked gate. No pesticide or chemical odors were detected during the inspection and no evidence of prior leaks or spills were observed or reported by Team Management. In addition, the City of Carrollton Fire Department and Building Inspection Department did not have any records of pesticide problems with Team’s tenant area. Storage practices appear to comply with local regulations.

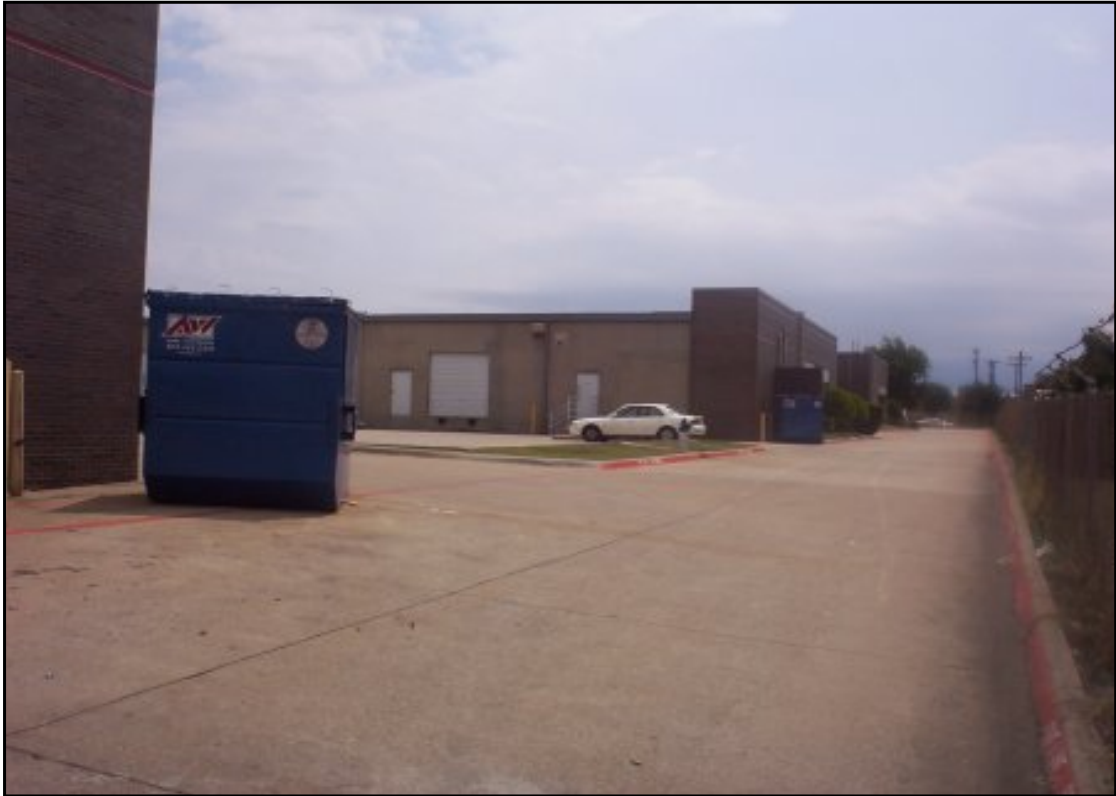
Dumpster

Solid waste on the Property is collected in three 10-cubic yard dumpsters situated at the south side of Building Two. The solid waste is collected once a week by Waste Management. The dumpsters were noted to contain miscellaneous cardboard at the time of the Property reconnaissance and no indication of potentially hazardous material disposal was noted during DEC’s reconnaissance.

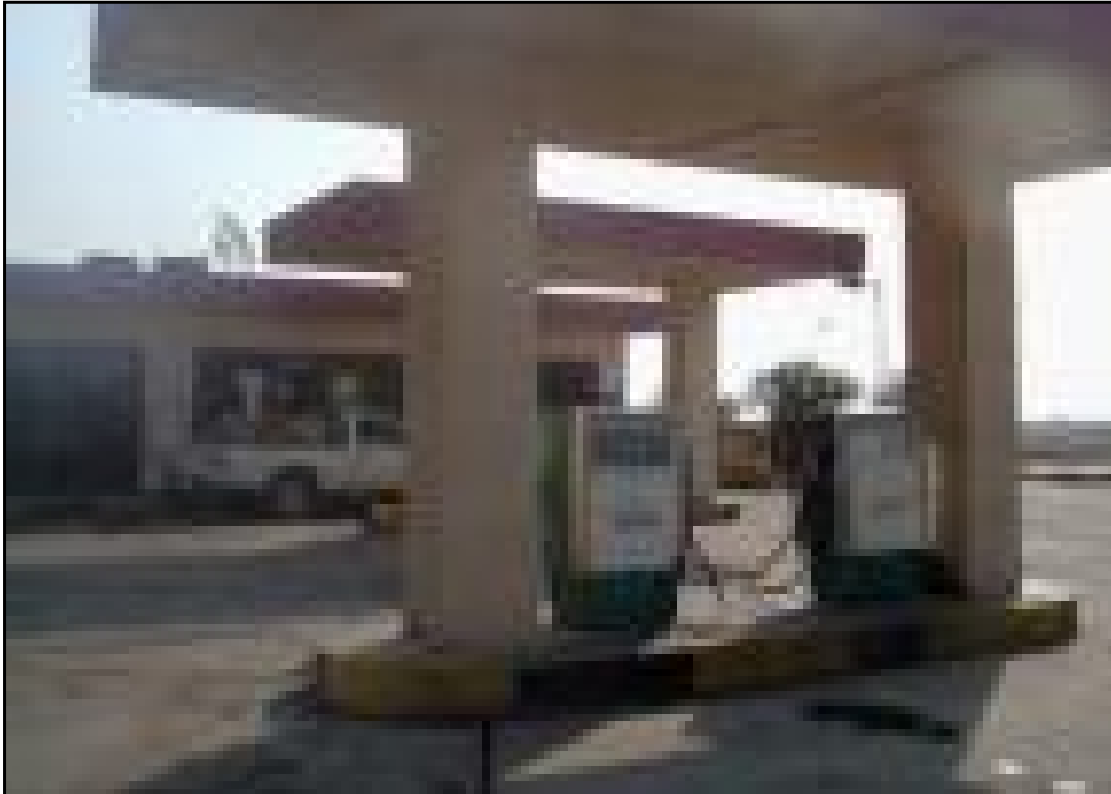
View of dispensers and island.
